## **Study of Present Situation and Future Prospect of Environmental and Safety**

### **Measures in Suburban Aggregate Mines in Japan**

This paper describes the present situation and future prospects of environmental and safety measures in suburban aggregate mines in Japan.

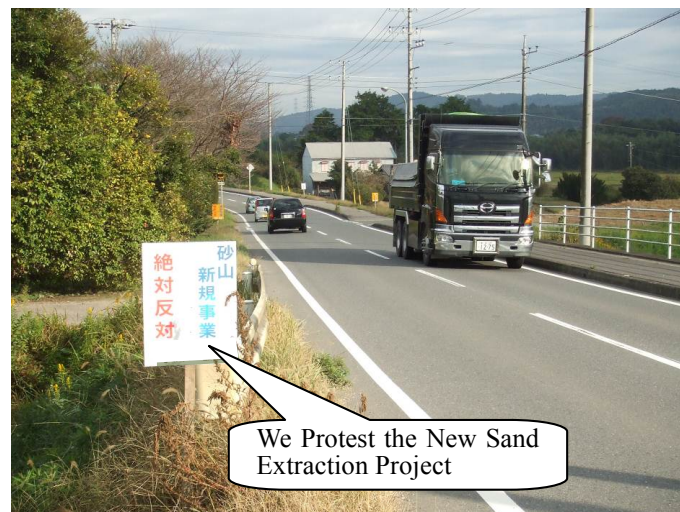
**Fig. 1** A sign put up by local residents protesting a new aggregate resources development.

Additionally, as shown in **Fig. 1**, it has become difficult to win the understanding of local residents regarding exploitation of aggregate resources because residents in the vicinity of excavation sites have experienced noise, dust and road accidents caused by dump trucks, illegal dumping of industrial waste at excavation sites, and large-scale soil runoff due to heavy rainfall. Accordingly, development of aggregate resources should be pursued while placing greater importance on ensuring the understanding and cooperation of local residents.

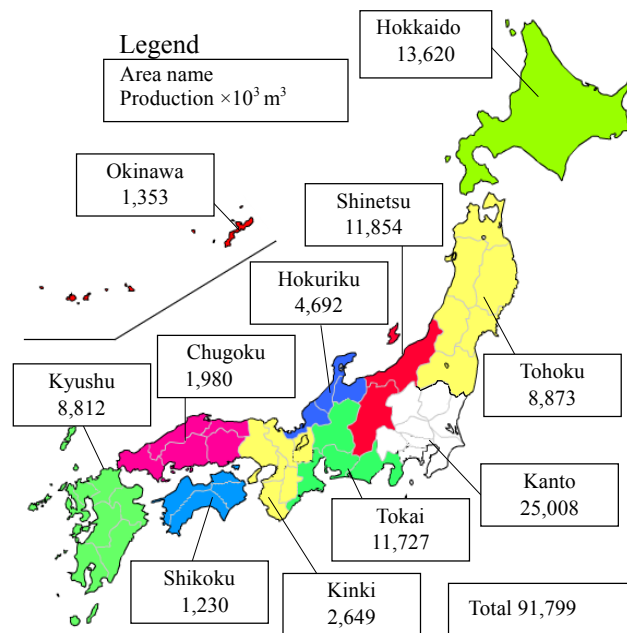
**Fig. 2** Area-wise natural sand and gravel production in 2009 <sup>2)</sup>.

little land/pit sand and gravel is distributed due to the lack of quaternary sedimentary rock formations. Sea sand and gravel are found in many places in the coastal waters and in the Seto Inland Sea. In the seas of Kyushu and Seto, where extraction condition is favorable, sand and gravel have been exploited for many years, and thus further development of aggregate resources is not expected. **Figure 2** shows the production of sand and gravel according to the area in fiscal year 2009 <sup>2)</sup>.

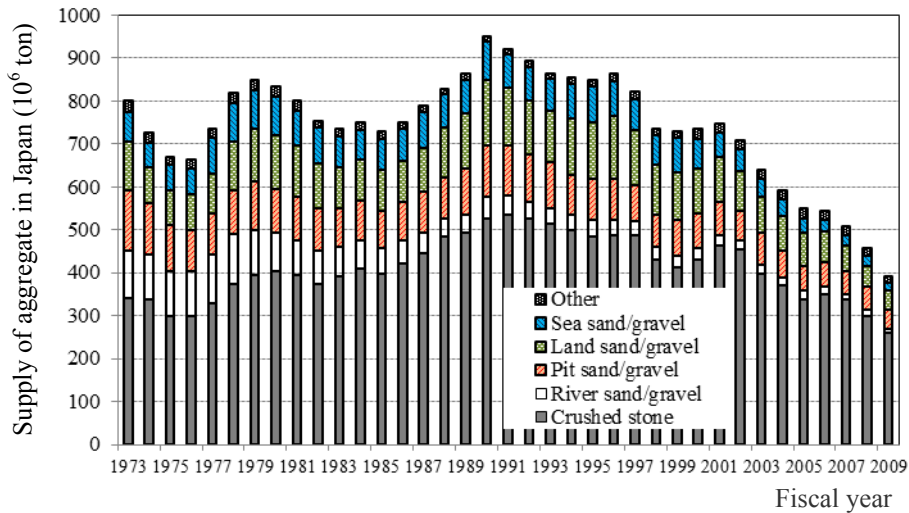
Fig. 3 Changes in the supply of aggregate in Japan <sup>1)</sup>.

The current consumption stands at around 390 million tons per year, of which one-third is natural aggregate. The past heavy consumption of aggregate now poses an increasingly serious problem, namely the insufficiency of quality sand. Additionally, restrictions on the extraction of sea sand and gravel are being strengthened for the purpose of advancing environmental measures. Use of recycled aggregate has been promoted, but it is not sufficient to meet the demand. In the past, use of crushed stone was effective in satisfying the increasing demand for aggregate.

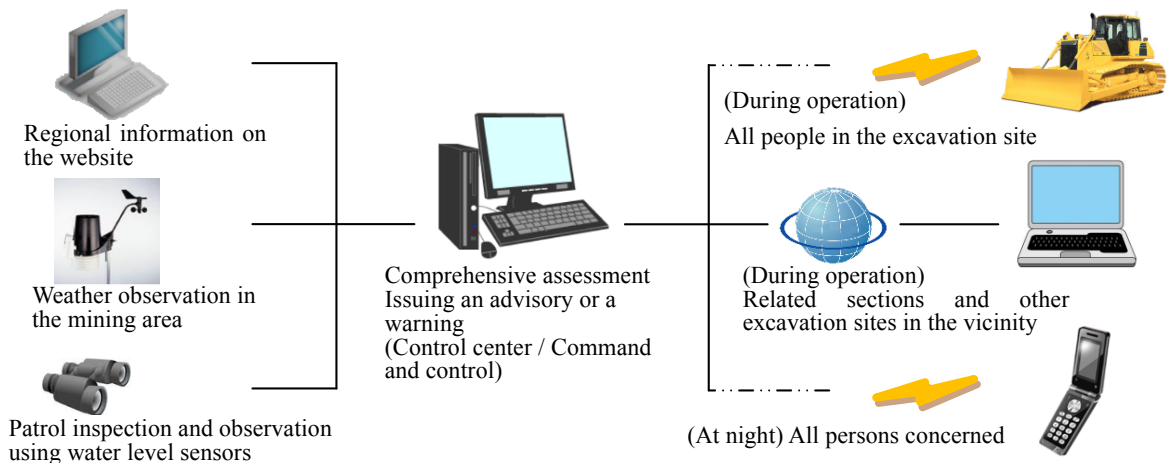
**Fig. 20** Conceptual plan of an emergency response system for small and medium excavation projects.

It is desirable that the current disaster prevention scheme at the T mine excavation site be further improved to shorten the time required for processing and analyzing various weather data before making a decision on necessary measures. As the frequency of extreme weather is increasing,

it is also hoped that a disaster prevention scheme will be established as a system which automatically issues an advisory or a warning to all people concerned any time, day or night, so that disasters which might be caused by extreme weather can be effectively prevented.

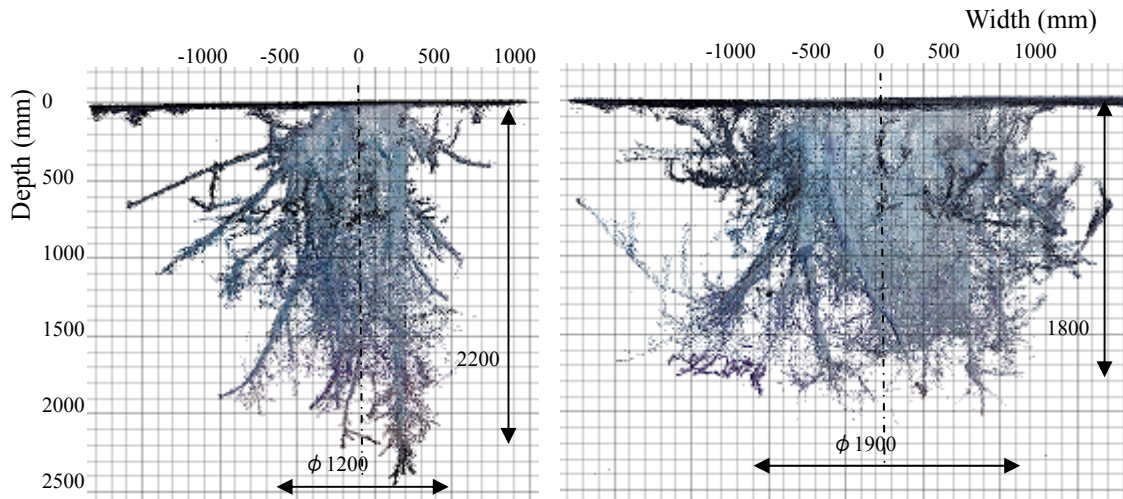
**Fig. 21** Growth of the rootstock. (Left: Japanese cedar, Right: Japanese cypress).

For the purpose of understanding in more detail the thickness and the area of improved soil which are required for planting, the roots of a Japanese cypress tree (71 years old, 19.0 m high) and a Japanese cedar tree (51 years old, 16.5 m high), both of which had been felled, were plowed up for analysis. A ground-based laser scanner, which is often used for three-dimensional surveying<sup>17)</sup> at mines, was used for scanning the roots. The cypress's rootstock after trimming and filtering (1 pixel per 1mm<sup>3</sup>) is shown in **Fig. 21**. The rootstock was 1,800 mm long and 1,900 mm wide, having a fibrous root system developed laterally. The cedar's rootstock was 2,200 mm long and 1,200 mm wide. Judging from the age of each tree, the rootstock can be regarded as the maximum size of each species. In planting 3-year-old seedlings 500 ~ 700 mm high, pedogenic process involving soil microbes in the course of the growth of the seedlings can be taken into account. In view of this, it is assumed that growth of one seedling is ensured by applying improved soil to an area which is 1,000 mm in diameter, although the dimension of the area may be slightly different depending on tree species. In that area, 1.17 m<sup>3</sup> of improved soil can be applied to a depth of 1,500 mm. Thus, when an extraction site is backfilled for planting, care should be taken to prevent a bulldozer or a power shovel from compacting the soil to a depth of 1.5 m from the finished surface.

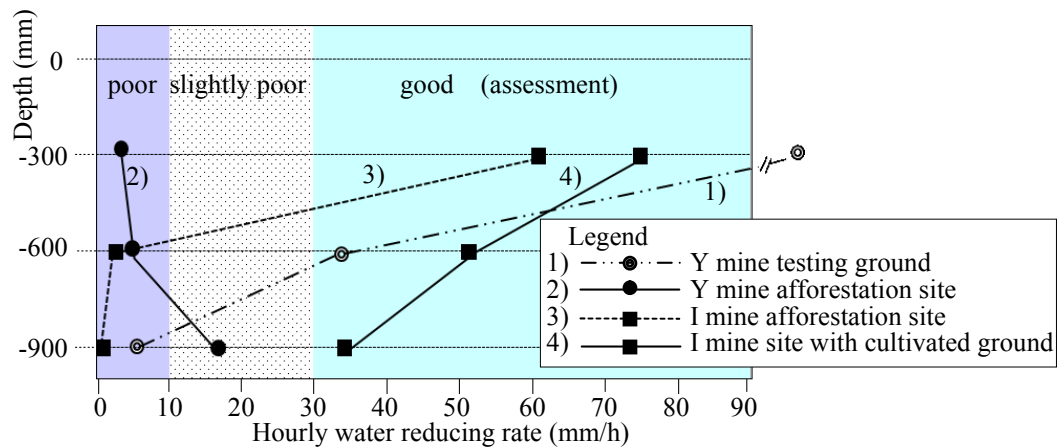
**Fig. 22** Soil permeability at each afforestation site, determined by a Hasegawa system of field permeability test apparatus.

Water permeability of improved soil is one of the physical factors that affect the growth of plants. Poor permeability results in excess water in the ground, which causes decreased oxygen supply to roots as well as generation of harmful substances by anaerobic microorganisms. Although sandy soil is presumed to have good permeability, a field permeability test apparatus was used for determining the permeability because past experience at the extraction site had indicated the possibility of poor permeability after rain. As shown in **Fig. 22**, at a depth of 300 mm in Y mine testing ground 1) where mount-shaped organic compost had been applied and Japanese cypress trees had been growing well, the soil permeability was so high as to make it almost impossible for the test apparatus to determine the permeability. While the permeability was also good at a depth of 600 mm, it was poor at the bottom of the compost at a depth of 900 mm. This result suggests that the bottom of the compost is on the top of the backfill consisting of pit sand and others, the same type of soil used for the planting ground at Y mine 2) which is 15 m away from Y mine testing ground 1). At the afforestation site 3) of I mine, a small bulldozer had been used to modify the slope and only the surface had been prepared before planting. Thus, while the permeability was good at a depth of 300 mm, the permeability at a depth of 600 mm and deeper was as poor as at site 2) of Y mine. At the site 4) about 2 m away from site 3), the ground had been cultivated in an area 1.0 m across to a depth of 1.5 m with a power shovel for the purpose of improving the permeability. The test conducted in two months after the cultivation showed that the permeability at a depth of 600 mm and deeper had been improved to the baseline value <sup>18)</sup>, 30 mm/hour or greater.
