Theoretical and Experimental Study on Tsunami Induced Instability of Caisson Type Composite Breakwater

Abstract

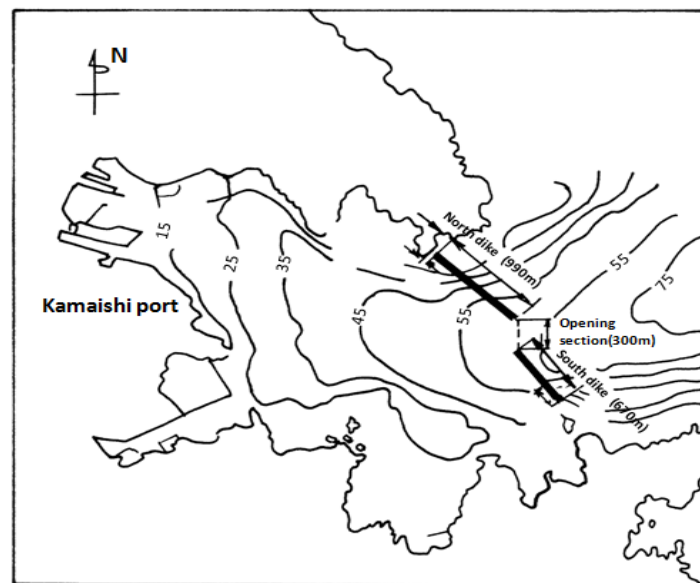
Fig. 1 Kamaishi breakwater layout in Kamaishi port²⁾, Iwate prefecture (after Uezono,1987)

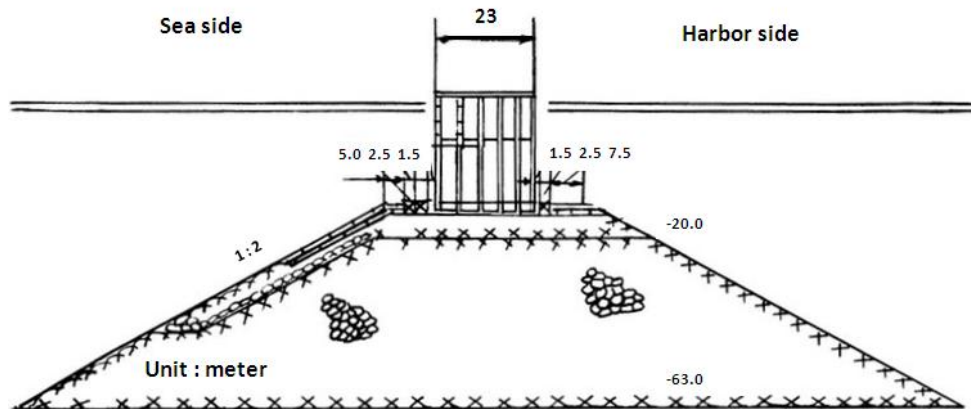
Fig. 2 Cross section of Kamaishi breakwater's southern dike, section 4.¹⁰⁾

The section 4 of Kamaishi breakwater south dike, the deepest part in the whole breakwaters, was chosen as the research section. The illustration of it is shown in **Fig. 2**.

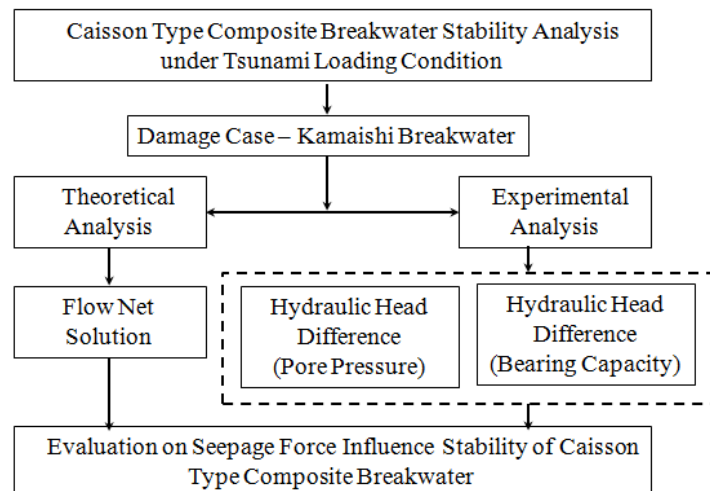
Fig. 3 Flow chart of stability analysis of caisson type composite breakwater.

From this study, a simplified failure criterion has been proposed to analyze the stability of the mound element under seepage condition. Two kinds of laboratory experiments have been planned to investigate the failure mechanism. **Figure 3** shows the research procedures.

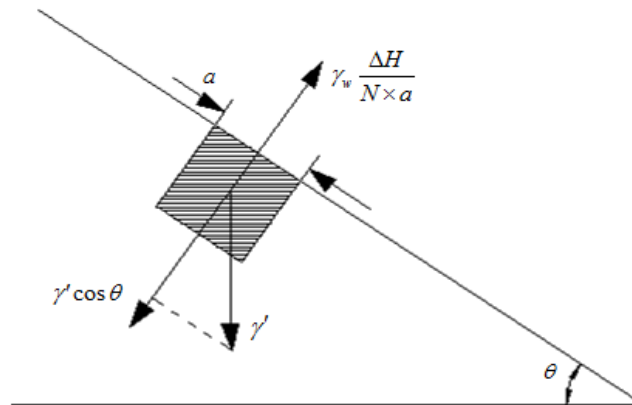
Fig. 4 Force decompose sketch of unite square on surface of rubble mound.

where γ' is the rubble mound’s effective unit weight, θ is the slope angle, γ_w is the unit weight of water, ΔH is the hydraulic head difference between the seaside and the harbor side, N is the number of equipotential line, and a is the length of the unit square inside the flow net as shown in **Fig. 4**.

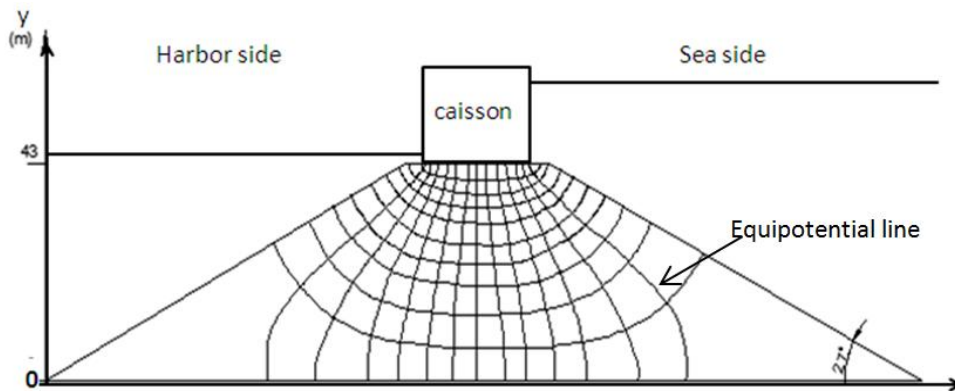
Fig. 5 Flow net illustration of Kamaishi breakwater.

Figure 5 applies the Kamaishi breakwater case data from the tsunami event and uses the theoretical method of calculation in order to find the failure area. The dimension data of Kamaishi breakwater were described as following: the caisson was 26 meters in width and 20 meters in height, slope angle of rubble mound was 27 degrees with the slope ratio equals to 1:2. The height of rubble mound was 43 meters. Hydraulic head difference from sea side towards harbor side was 13.64meters. The calculated data are given as $\gamma_w = 1 \text{ N/m}^3$; $\gamma' = 0.8 \text{ N/m}^3$; $\theta = 27^\circ$; $N = 14$;

$\Delta H = 13\text{m}$ and the value of “ a ” is obtained from **Fig. 5**.

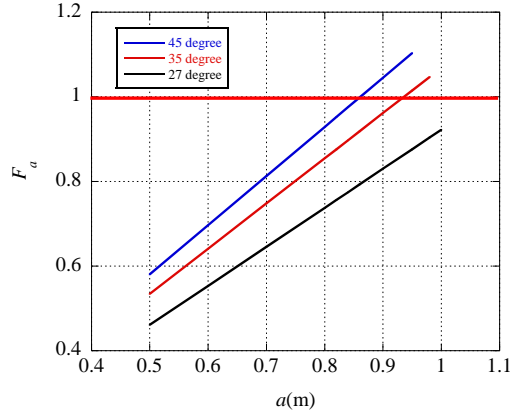
Fig. 6 Relationship between a and F_a with different slope angle (same hydraulic head difference).

In order to get a deeper understanding of the influence of seepage flow on the stability of the rubble mound, parametric studies were carried out to investigate the relationship between slope angle and the value of “ a ” as well as the relationship between hydraulic head difference and the value of “ a ”. The results were shown in **Fig. 6** and **Fig. 7**. In these two figures, the vertical axis represents the value of calculated F_a . The solid red lines shown in **Fig. 6** and **Fig. 7** imply that when F_a is equal to 1, the values of “ a ” above solid red line were the unstable areas. Therefore, the critical value of F_a can be obtained from the graphs. Major trends of the development of these values are concluded as: the value of F_a decreases when slope angle increases under the condition of constant hydraulic head difference. On the other hand, the stability of rubble decreases when hydraulic head difference increases for the same breakwater.

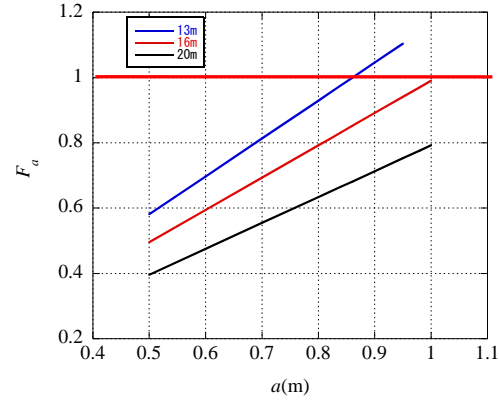
Fig. 7 Relationship between a and F_a with different hydraulic head differences (same slope angle).

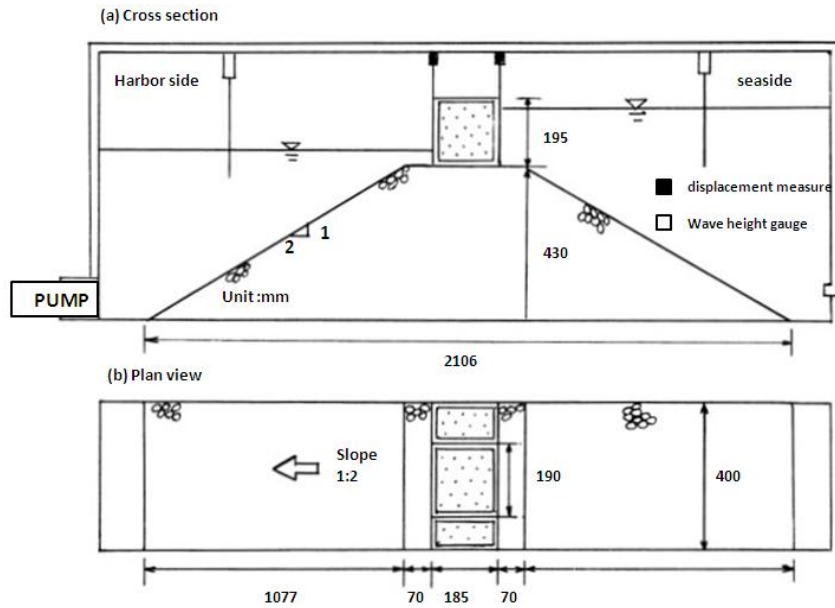
Fig. 8 Layout of experiment model in water tank (script).

A model for laboratory experiment was established by simulating the Kamaishi breakwater's southern dike, section 4 at a scale of 1/100. The rubble mound material is crushed stones of which D_{min} is 2mm, D_{max} is 35mm and D_{50} is 10mm. The dimensions of caisson are 195mm in height, 185mm in length and 190mm in width. The caisson was filled with sand. The density of sand is 2.03 g/cm^3 . In order to reproduce the effects of hydraulic head difference on caisson type breakwaters during tsunami waves, three pumps were introduced to create hydraulic head difference. The experiment layout was shown in **Fig. 8**. The cross section view of the caisson type composite breakwater located in water tank is shown in **Fig.8** as (a) cross section. A pump system was established to control the hydraulic head difference from the sea side towards the harbor side of the physical model. Legend in **Fig.8** shows the installations of measuring equipment. The plan view of the physical model is presented in Fig.8 as (b) plan view. All the equipments were set on the caisson which was located in the middle of tank. The two side caisson boxes among three caisson boxes were placed to avoid the friction effect along tank walls. All the dimensions are shown in **Fig. 8**.

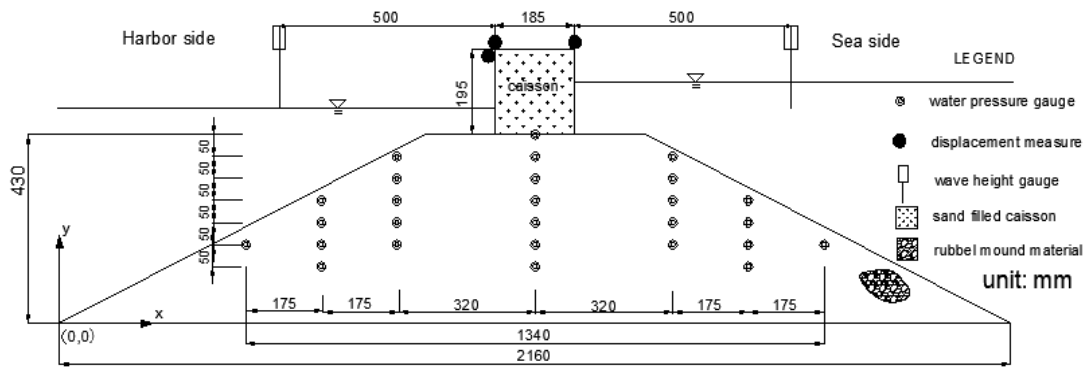
Fig. 9 Experiment equipments settings.

The objective of the experiment is to observe the failure phenomena when hydraulic head difference is created. Water pressure gauges were embedded in the rubble mound to investigate the variation of pore pressure during the experiment, and wave height sensors were set on both sides of the caisson as shown in **Fig. 9**. The x-y coordinate was used as shown in **Fig.9** and initial point was also given in the graph for later coordinate reference. The experimental data were collected electronically and processed by computer.

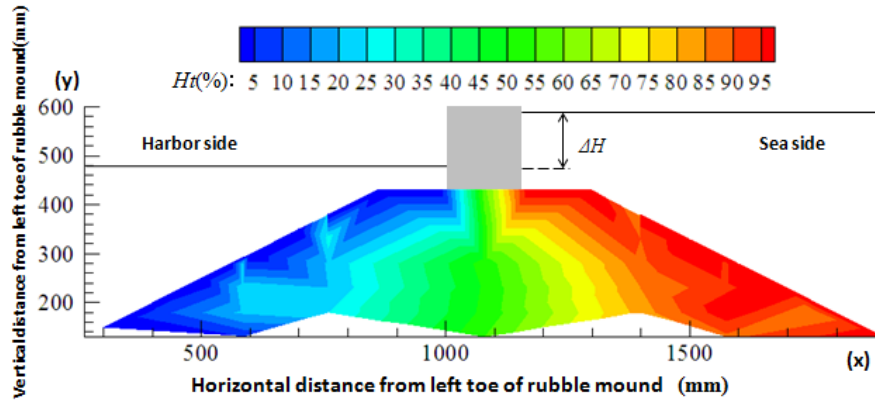
Fig. 10 Pore pressure distribution generated by the hydraulic head difference.

Data from the above experiments were processed and utilized for calculation. In Fig.10, only the upper part of rubble mound in Fig.9 where the pore pressure gauges were installed area is demonstrated. The starting of x-axis is set 300mm from the left toe of rubble mound and y-axis is set 130mm from the left toe of rubble mound. From the pore pressure data obtained in the experiment, the hydraulic gradient distribution was illustrated as in Fig. 10 by Tecplot software¹⁴⁾. It represents that the hydraulic head difference generates great pore pressure from the seaside towards the harbor side, which might cause the instability of rubble mound.

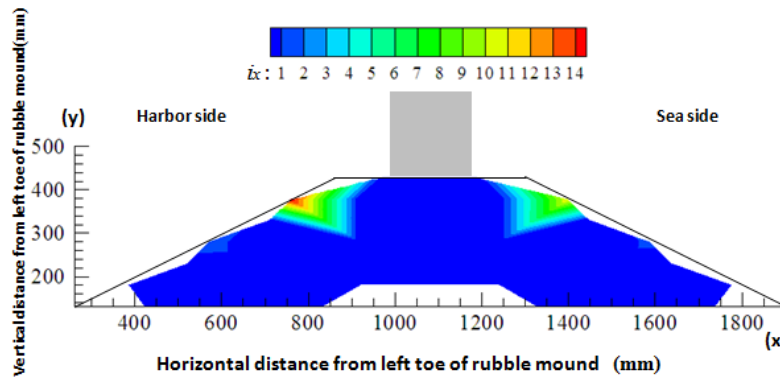
Fig. 11 Hydraulic gradient distribution in the horizontal direction.

Figure 11 and Fig. 12 show the calculation results from Eq. 4. From the plots, it can be concluded that the hydraulic gradient concentration is greater in the horizontal direction than the vertical direction with the same hydraulic head difference of 118mm.

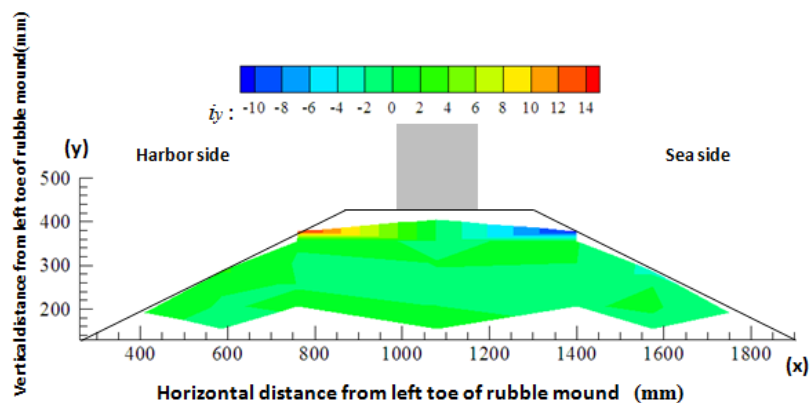
Fig. 12 Hydraulic gradient distribution in the vertical direction.

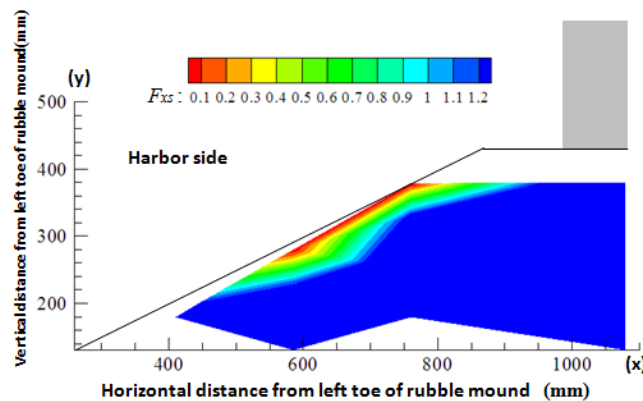
Fig. 13 F_{xs} calculated by failure criteria.

The calculation result is shown in **Fig.13**. It can be seen that when hydraulic head difference is 118mm, the rubble mound slope surface area with depth of 62.3mm has failure potential. This corresponds 6.2 m at full scale. However, in the laboratory modeling tests, the “pop out” failure due to seepage forces is hardly found. Although the hydraulic gradient shows a concentration on the surface of the rubble mound and F_{xs} have been dramatically reduced, it is less likely that the excessive pore-pressure (seepage force) can cause the catastrophic failure at hydraulic head difference of 118mm. This leads to the hypothesis that the combination of seepage force with downstream surface erosion caused by overtopping might be the major cause of caisson type breakwater failure. Detailed investigation and experimentation focused on this failure mechanism should be carried out. Besides the suggestions given above, the lack of failure observed under these wave conditions might be due to the selection of rubble mound material in this experiment. Finer rocks with smaller diameters should be tested in later experiments.

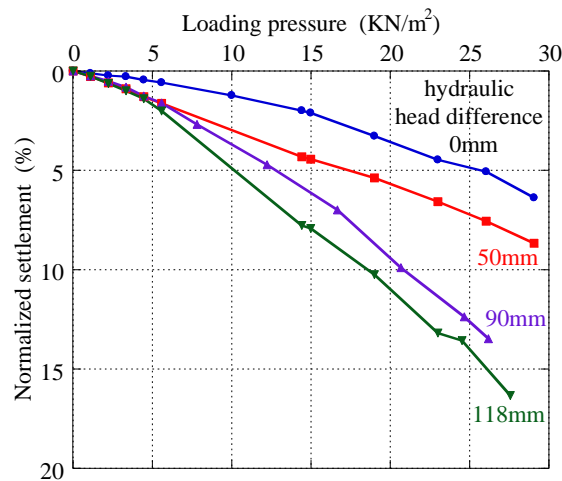
Fig. 14 Relationship between loading pressure and normalized settlement of caisson.

When weight was loaded on the caisson, displacements of the caisson were observed, and these displacement data were collected at certain hydraulic head difference. The settlement values have been compared in **Fig. 14**.

The settlement of caisson due to weight loading shows a trend: when loading increases, the settlement becomes larger. As expected, the larger hydraulic head difference influenced the bearing capacity of the rubble mound. The curves show a clear tendency that the settlement increases about 50% when hydraulic head difference increases from 0mm to 118mm. It is indicated that the displacement of caisson becomes larger when the hydraulic head difference becomes larger. It might trigger entire failure of rubble mound at a certain value of hydraulic gradient. In other words, it is found that the seepage force contributes to reduce the bearing capacity of rubble mound.

The analysis of the results in **Fig. 14** and **Fig. 15** show that pore pressure generated by seepage flow brings the decreases of effective stress which may cause instability of the caisson. Therefore, it is necessary to calculate the entire stability of rubble mound to analyze the influence of seepage flow on the caisson type breakwaters.

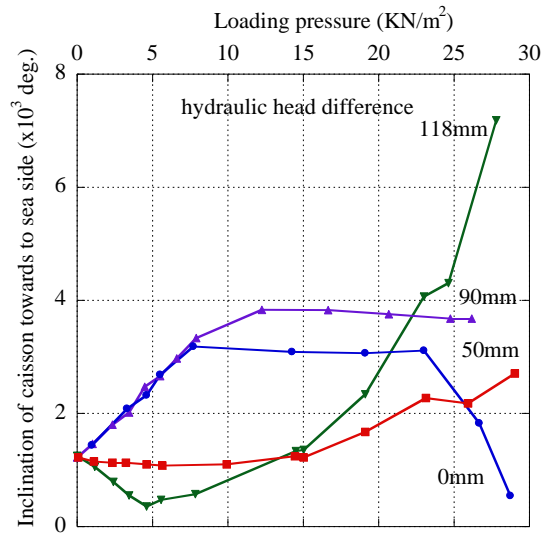
Fig. 15 Relationship between loading pressure and inclination of caisson towards to sea side.

Figure 15 shows the relationship between the caisson incline angle and weight loading. When the hydraulic head difference stays constant, the loading value reaches 15 KN/m². The settlement of the caisson develops significantly when the loading increases to 25 KN/m², and the biggest hydraulic head difference (118mm) creates the largest settlement. In other words, the increase of hydraulic head difference has a negative influence on the stability of caisson and with such a big displacement.

The inclinations were also calculated from this experiment and from the results in **Fig. 15**. The deformation of the rubble mound becomes significant when hydraulic head difference increases, in this case to 118mm, and the caisson is prone to be less stable when hydraulic head difference is large.

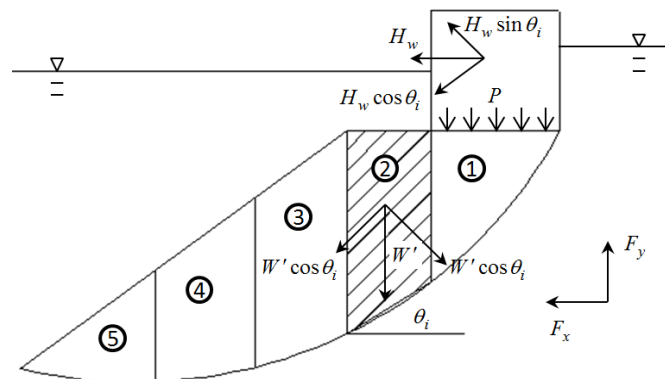
Fig. 16 Model of circular failure analysis.

as illustrated in **Fig. 16**. It shows the calculation of characteristics of the slip surface on the rubble mound with mathematical equations given as follows:

$$\begin{aligned}
 R_i &= \left[(P+W') \cos \theta_i - H_w \sin \theta_i - F_x \sin \theta_i - F_y \cos \theta_i \right] \tan \phi' \\
 S_i &= (P+W') \sin \theta_i + H_w \cos \theta_i + F_x \cos \theta_i - F_y \sin \theta_i \\
 F_s &= \sum_{i=1}^n R_i / \sum_{i=1}^n S_i
 \end{aligned} \quad \left. \vphantom{\begin{aligned} R_i \\ S_i \\ F_s \end{aligned}} \right\} (7)$$

where P is the weight of the caisson itself, H_w is the horizontal water static load, F_x and F_y are the decomposed seepage force in the horizontal and vertical components respectively, the subscript i is the number of each slice of potential failure, θ_i is the angle of slice slip surface towards the horizontal direction, W' is the effective weight of the rubble mound, R_i is the resistance force and S_i is the shear strength. In these equations, when F_s is larger than one, the caisson is stable.

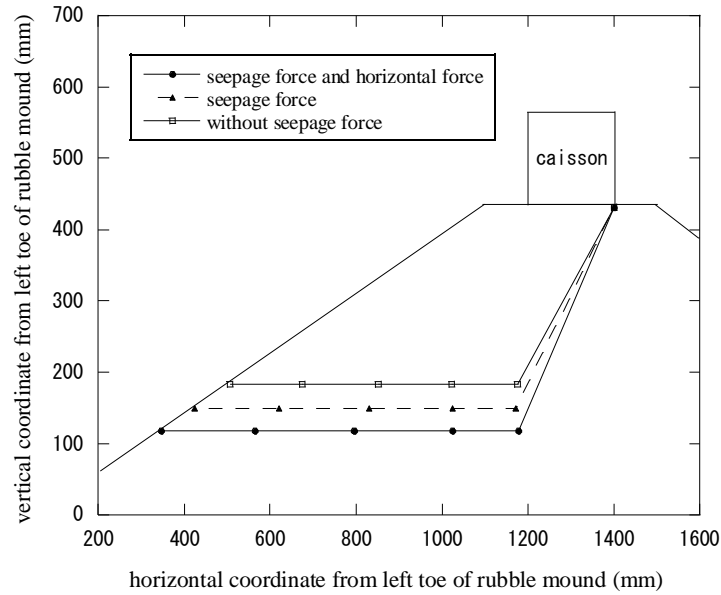
Fig.17 Comparison of slip surface calculation of rubble mound under tsunami loading and without seepage condition.

In order to get a clear understanding of the seepage force influence on caisson stability, further calculations were done and the results are shown in **Fig.17**. The locations of slip surface indicate the influence of seepage flow in rubble mound. By comparing with three conditions, the results show that the slip surface which induced by static horizontal force and seepage force is the shallowest line among three lines, the shear outlet of slip surface moved from the bottom of rubble mound towards the top of rubble mound significantly compared with conditions with seepage flow and without seepage flow in rubble mound.
